BMW 576 Warning Insert
M-MIS-90254

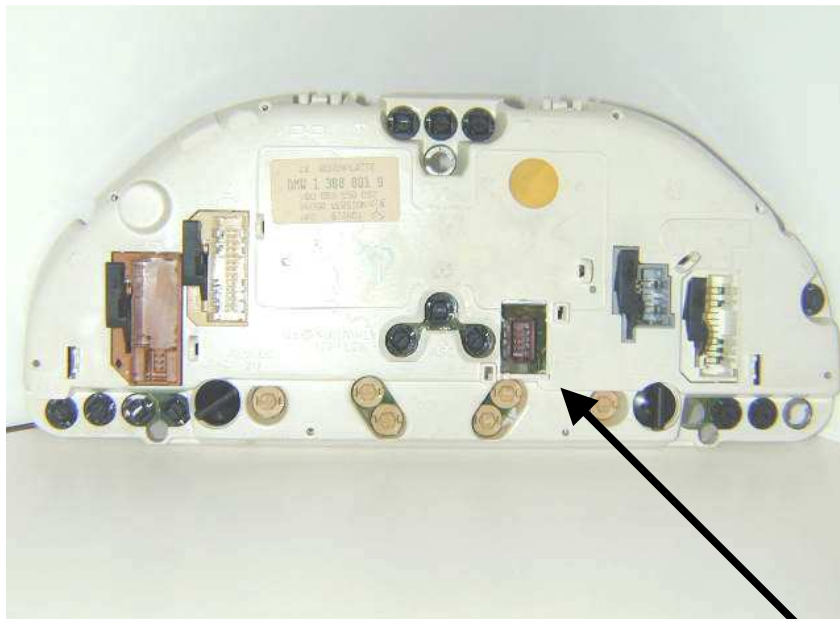
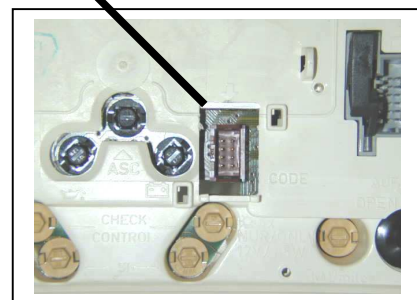
Location for CODE PLUG

You must make sure that the CODE PLUG on the original board is good before transferring it to the new board!!

If a bad plug is inserted on this remanufactured unit damage may occur and the warranty will be void.
